# **Frederick-Firestone Fire District**

# **Table of Contents**

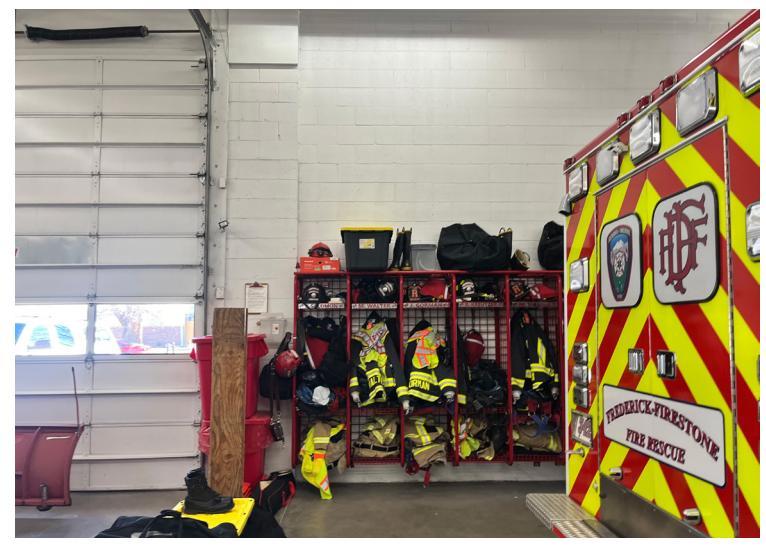
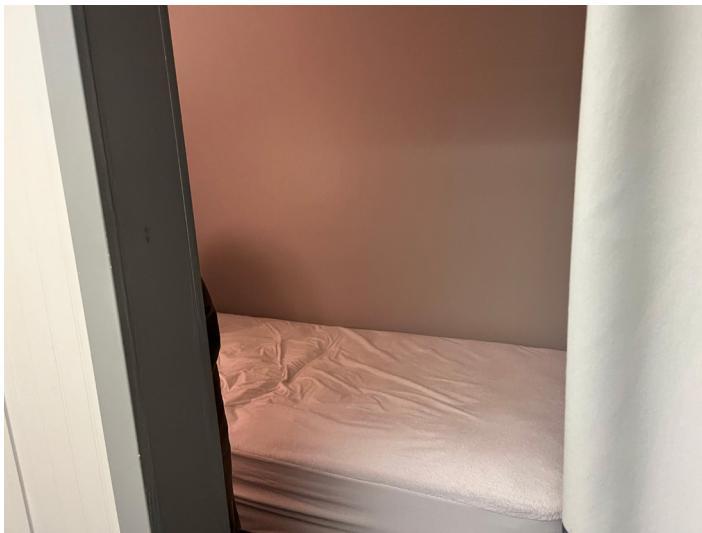
#### Exhibit B

(Above) PPE stored in bays. (Left) Very small bunk area.

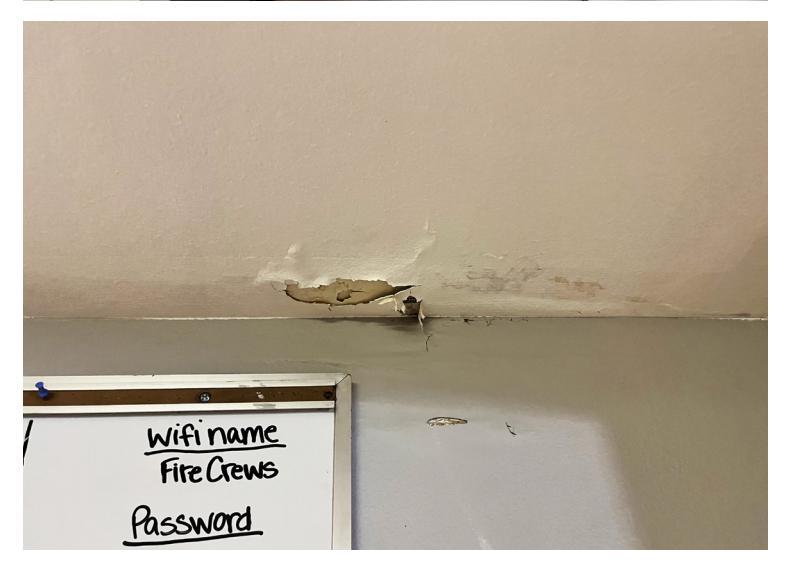
#### Exhibit A

**Condition** – The station is old and outdated. It does not meet current NFPA 1500 standards, nor does it appear that the NFPA 1500 standards were applied with the 2003 expansion. This leads to numerous crew safety and operational readiness issues since the station does not have automatic fire sprinklers or a central alarm system. PPE is currently stored in the bays which is not in line with best firefighter cancer prevention practices. The facility lacks a decontamination area. The bunk area is extremely small for six personnel and does not provide for privacy. The station is inadequately maintained as evidenced by the water leak in the dining room ceiling. **See Exhibit A.**

Water leak in dining room.

**Recommendation** – To ensure the health and safety of station crews, FFFD should make a Station One remodel/rebuild/replacement a high priority. FFFD may consider a Facility Condition Index model to guide its rebuild or replacement decision. **See Exhibit B**. Likewise, FFFD may wish to engage an architect to determine the proper course of action. The current condition affects the station's operational readiness. Without fire safety devices, this station could suffer a catastrophic loss and inability to provide emergency services. Furthermore, a better work environment can improve staff retention, job satisfaction and recruitment.

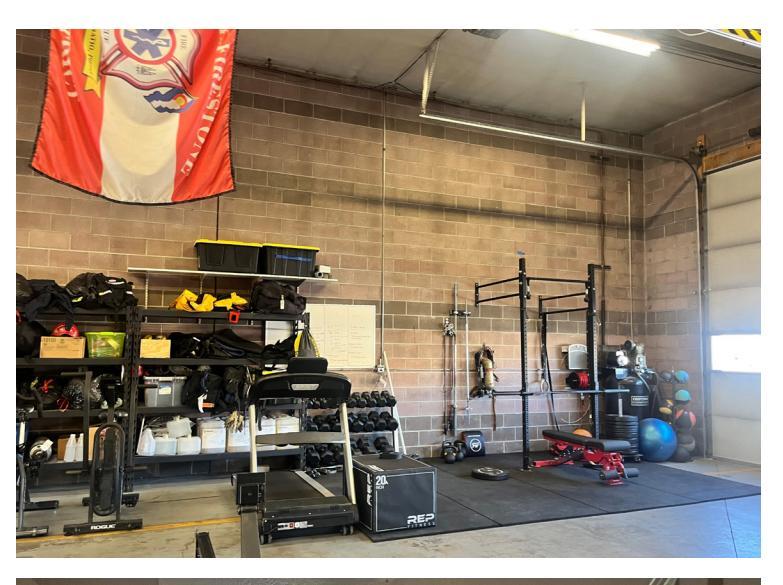
### Exhibit C

**Condition** – The building, although small for a modern fire station, appears to be well maintained. The station does not meet current NFPA 1500 standards. Significant safety concerns are that it lacks a separate room for turnouts; the fitness area is located in the apparatus bay; lacks a central alarm; lacks a decontamination area and lacks an automatic sprinkler system. **See Exhibit C.**

Station Two - fitness area located in apparatus bay.

**Recommendation** – Although not as a high priority as Station One, this station should be remodeled/replaced/rebuilt so that it meets current standards. The FCI model and an architect may be helpful in determining the right path. The lack of safety features may also affect the operational readiness of this station. The pending Station Five, located 2.8 miles away, provides a unique opportunity to temporarily relocate Station Two crews until Station Two can be corrected. Ironwood assesses this to be a medium priority, as the budget allows.

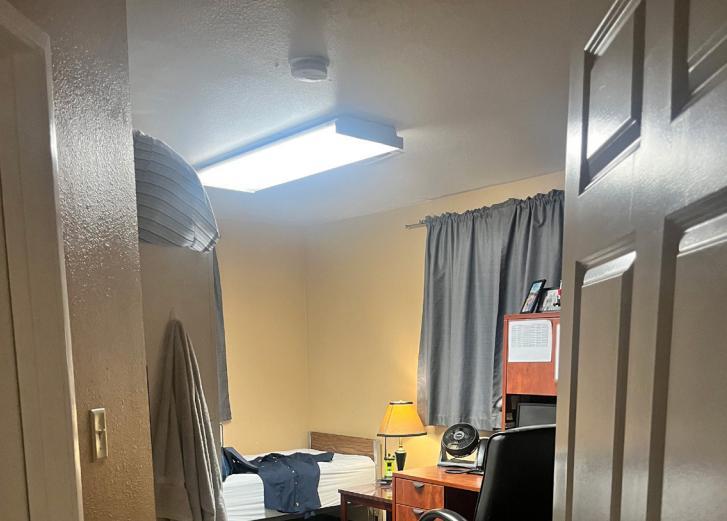
No central sprinkler system.

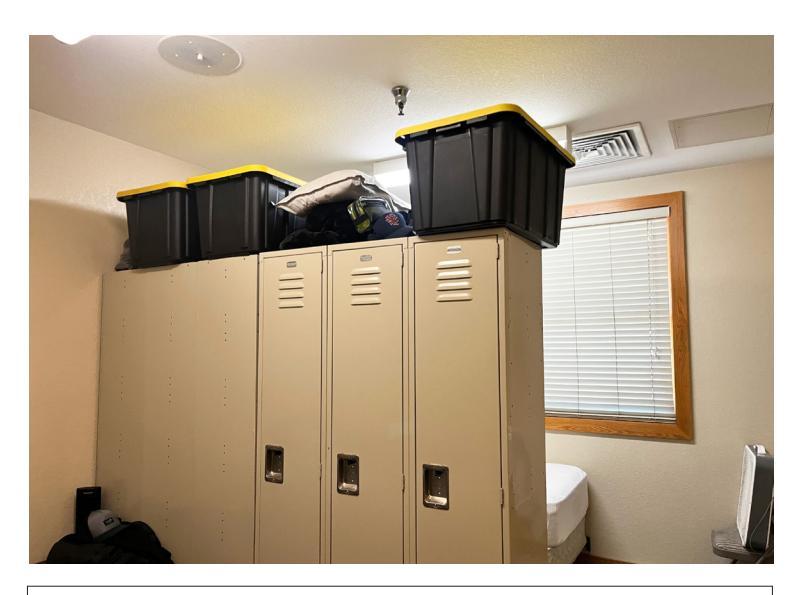
#### Exhibit D

It is reported that the bunkroom lockers are too small which leads to tubs being stored on top of lockers that could interfere with the sprinkler system. **See Exhibit D.**

Station Three - sprinkler interference.

Station Three - problematic bunkroom and bathroom configuration.

**Recommendation** – FFFD should make a reasonably timed plan to update Station Three so that it meets current NFPA standards. With this remodel, the station should also address privacy issues related to mixed bunkrooms and the use of Jack and Jill bathrooms.

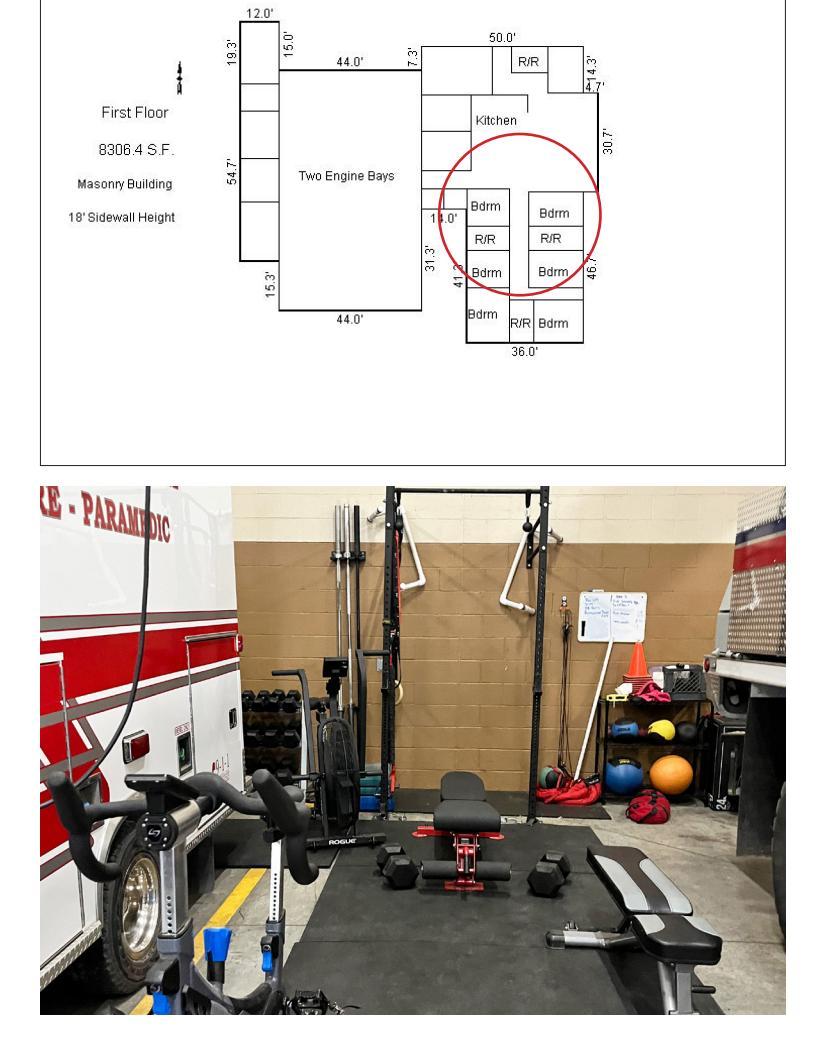
Workout equipment located in bay.

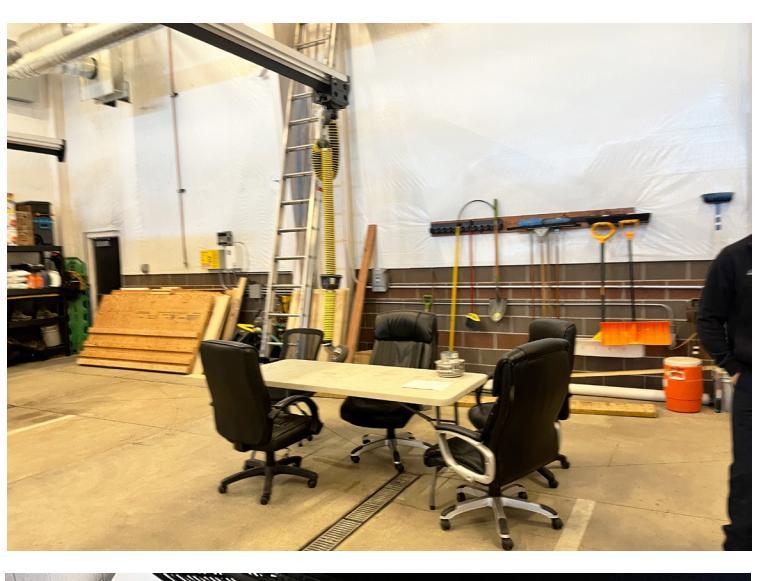
#### Exhibit E

This station uses multi-occupancy bunkrooms and Jack and Jill bathrooms. As reported with Station Three, these designs may affect firefighter morale, operational readiness and cause sleep deprivation. Likewise, there is a problem of using totes on top of small lockers. The site visits also revealed some minor housekeeping issues in the bays and the blocking of safety-related ventilation systems. **See Exhibit E.**

Station Four - minor general housekeeping needed in bay.

**Recommendation** – FFFD should rectify the issue with the ventilation system and bay clutter. Although a low priority, FFFD should evaluate its ability to remodel this station's bunkroom and bathroom configuration and correct the drainage issue in the front apparatus bays.

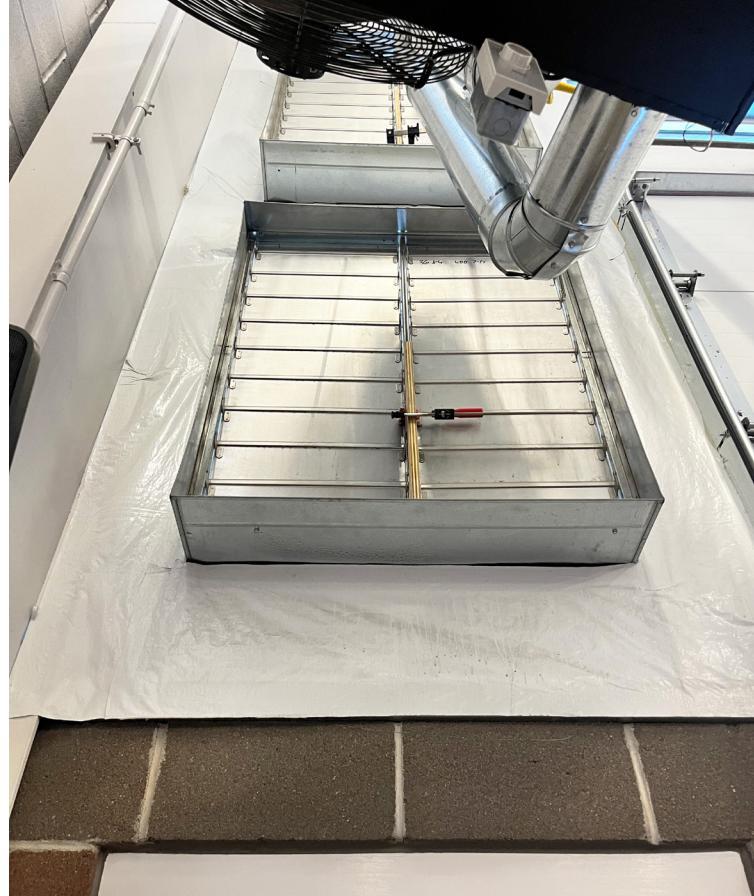
Crews reported this was necessary to avoid cold wind infiltrating bays. Consider consulting with an HVAC contractor to adjust/replace springs so it works appropriately.

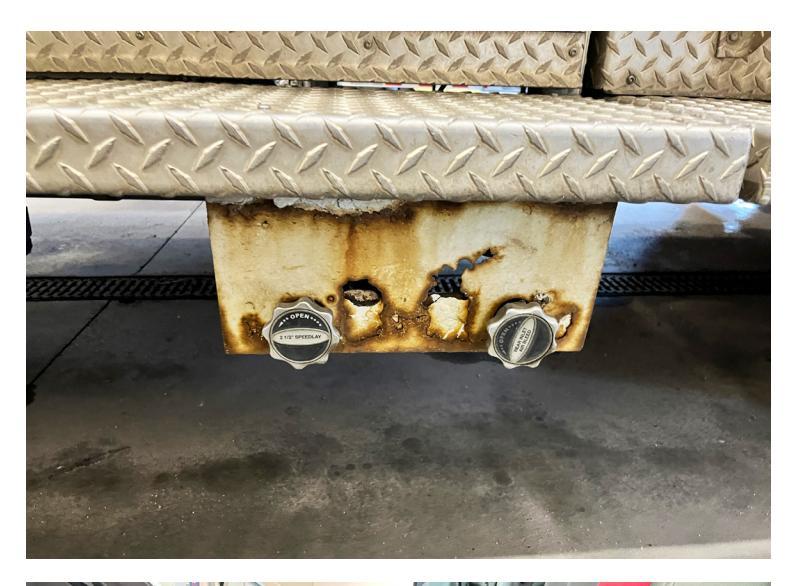
#### Exhibit I

**Condition** – FFFD currently has a relatively older fleet with the average and median age of 11 years with some exceptionally older vehicles. Analysis shows that this agency currently has three front-line apparatus that exceed 15 years and three trucks that exceed 20 years. **See Exhibit H.** These ages exceed the NFPA 1900 recommended replacement schedule. The extended age will be mitigated by the upcoming purchases of a rescue engine and two ladder trucks. A visual review of the apparatus show they are very worn. Potential causes can be a combination of age, excessive wear, historical lack of a recognized engineer program and historical lack of in-house mechanic and extensive maintenance. **See Exhibit I**.

Excessive age and needed repair.

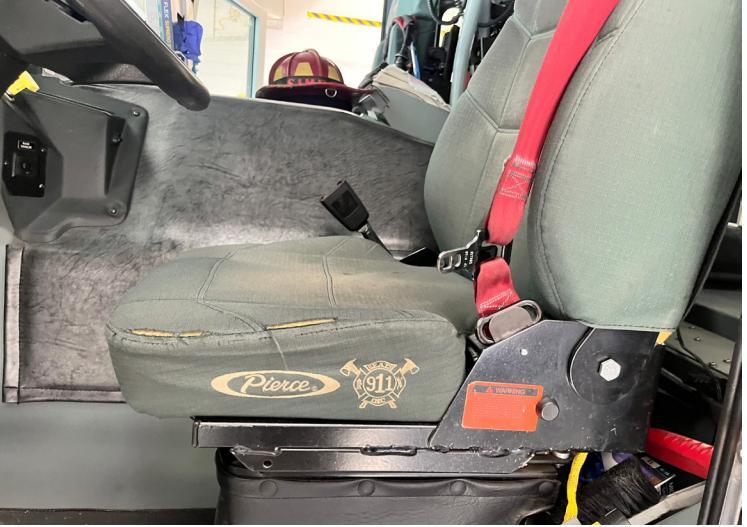
Excessive wear and needed repair.
