# **Frederick-Firestone Fire District**

# **Table of Contents**

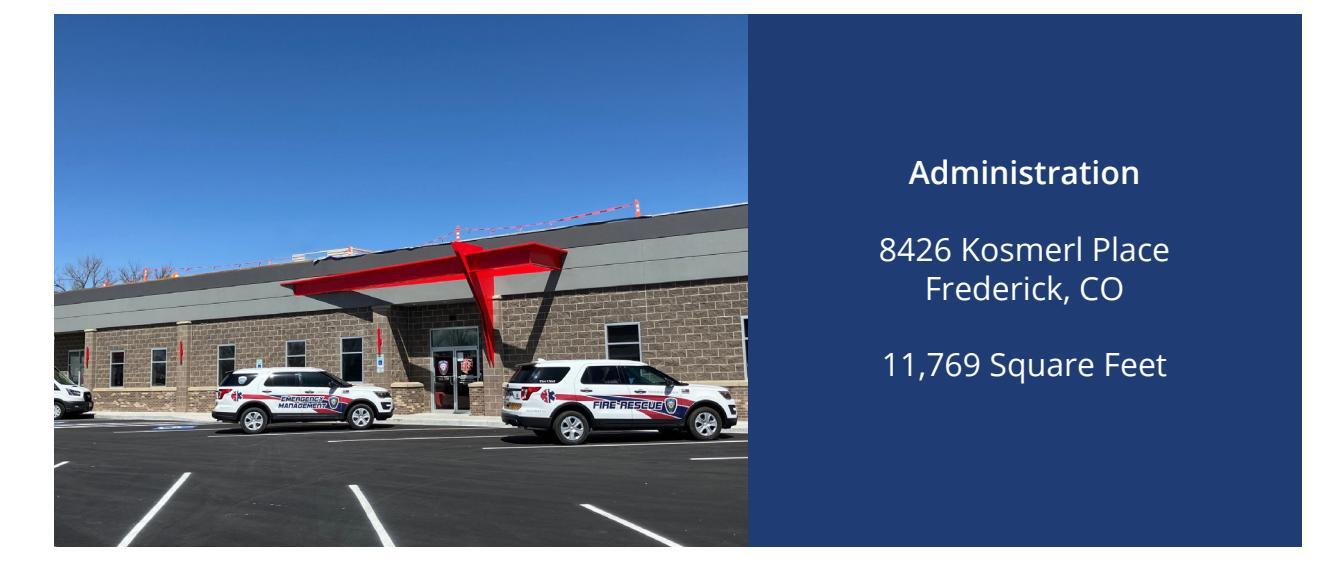
The administration building is located next to Station Two. It was constructed in 2005 as an office building but purchased in 2011 by FFFD. It is currently undergoing a remodel. Remodeling included all pertinent code updates, new HVAC systems, 10 new offices and a large training/community room. Staff indicates that the remodeled building has received its Certificate of Occupancy and will open in April 2024.

**Condition** – The building was not assessed since it was under construction. There is more vacant space in the area that the district could consider purchasing for any future expansion needs. At 11,769 square feet, the building should be able to serve the needs of the staff.

Recommendation - None.

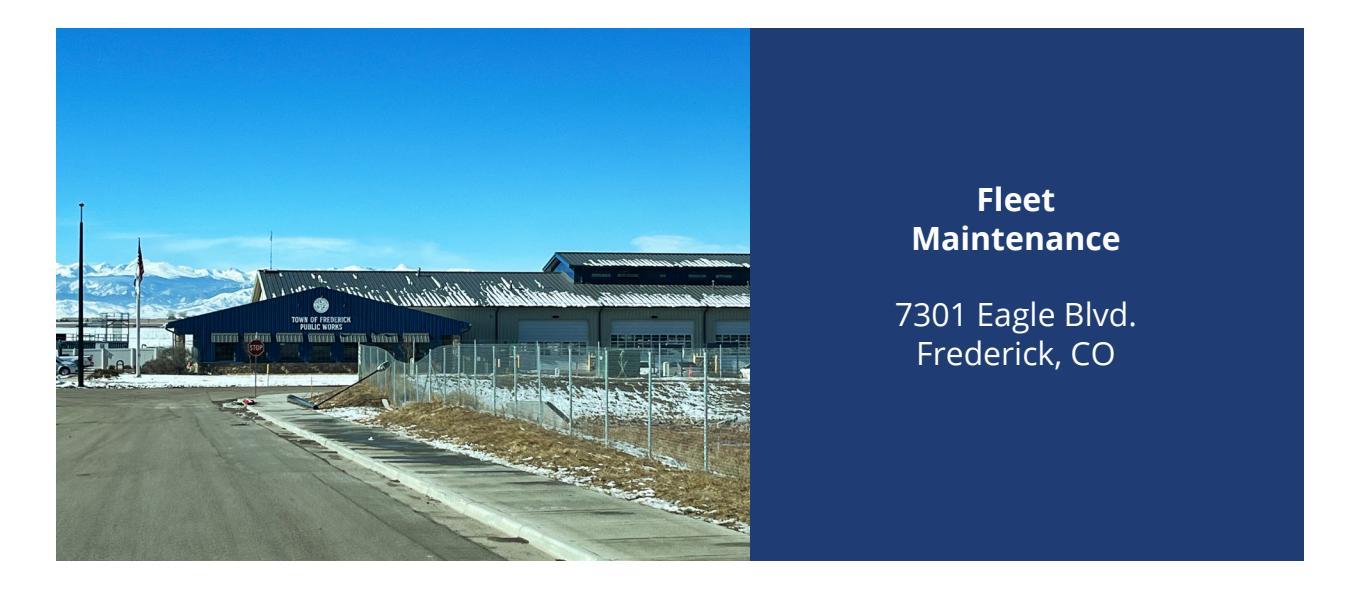
FFFD currently only has one emergency vehicle technician. As such, FFFD has strategically partnered with the Town of Frederick to provide fire apparatus repair bay space at the Town of Frederick's Public Works Building. The building was opened in 2014. Staff advises that the district is planning construction of its own maintenance facility in Fall 2025.

**Condition** – The facility itself is assumed to be adequate.

**Recommendation** – FFFD needs to expand its fleet repair facility and personnel as the district grows. Government Fleet publication – dedicated to serving the needs of public sector fleet management – generally recommends that there is one EVT for every 30 vehicles operated by a fire department. This generalization assumes that in-house maintenance has been in effect for many years and that apparatus is generally in good shape.

Facility site visits indicated that many front-line apparatuses are older and FFFD has only recently moved vehicle repair in house. Some agencies use a formula of one EVT for every eight heavy apparatus and one EVT for every 20 ambulances. FFFD needs to develop a better staffing model to achieve effective EVT staffing.

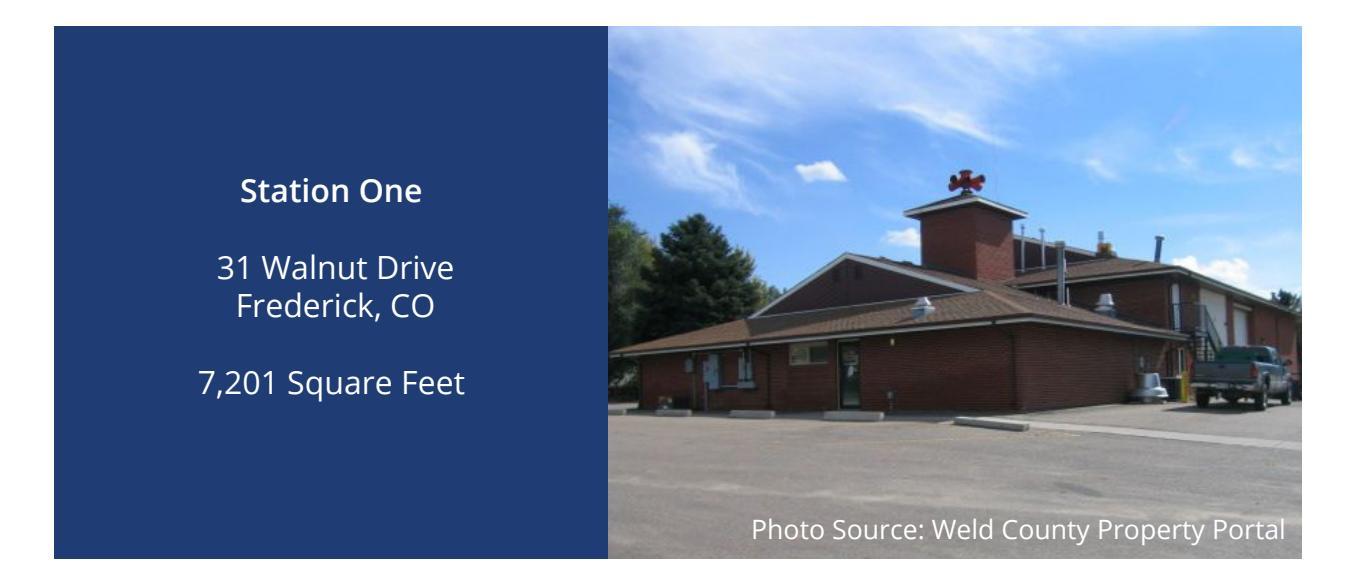
Station One was purchased in 1981 when FFFD was still a volunteer agency. It is the busiest station in the district. The building was originally 5,160 square feet and it was primarily designed to house fire apparatus only. As FFFD added paid staff, an 1,800-square-foot addition was added for crew quarters in the early 1990's. The building is now 7,201 square feet.

**Condition** – The station is old and outdated. It does not meet current NFPA 1500 standards, nor does it appear that the NFPA 1500 standards were applied with the 2003 expansion. This leads to numerous crew safety and operational readiness issues since the station does not have automatic fire sprinklers or a central alarm system. PPE is currently stored in the bays which is not in line with best firefighter cancer prevention practices. The facility lacks a decontamination area. The bunk area is extremely small for six personnel and does not provide for privacy. The station is inadequately maintained as evidenced by the water leak in the dining room ceiling. **See Exhibit A.**

**Recommendation** – To ensure the health and safety of station crews, FFFD should make a Station One remodel/rebuild/replacement a high priority. FFFD may consider a Facility Condition Index model to guide its rebuild or replacement decision. **See Exhibit B**. Likewise, FFFD may wish to engage an architect to determine the proper course of action. The current condition affects the station's operational readiness. Without fire safety devices, this station could suffer a catastrophic loss and inability to provide emergency services. Furthermore, a better work environment can improve staff retention, job satisfaction and recruitment.

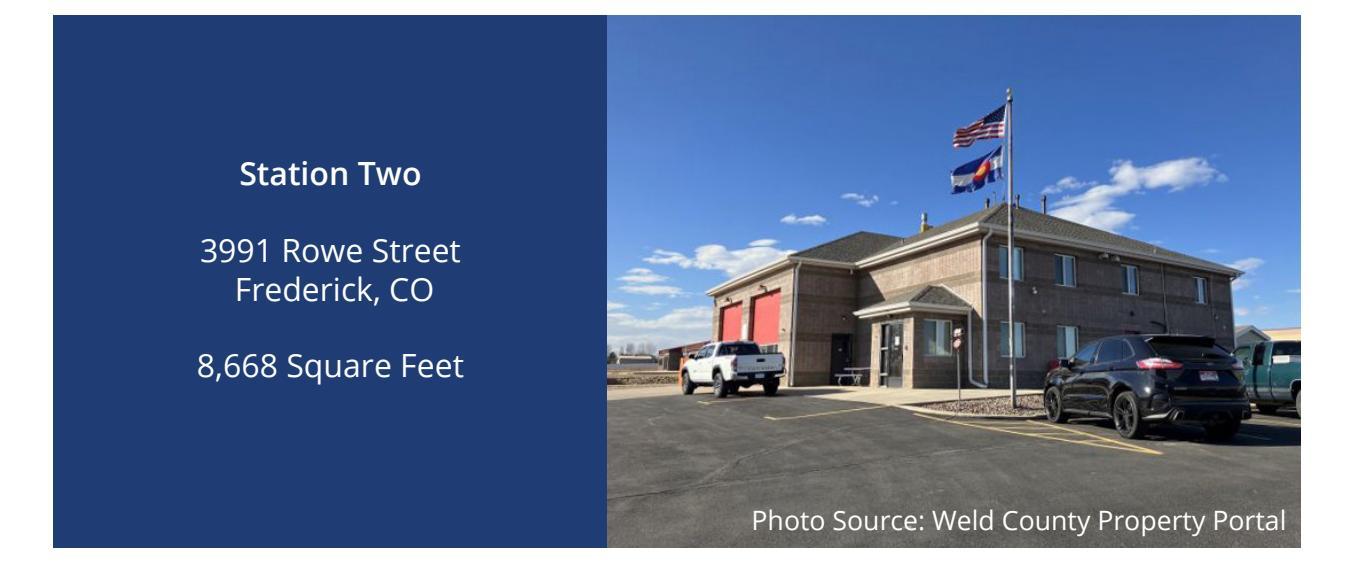
Station Two was built in 1995 and is 8,668 square feet. This station sits adjacent to Administration. The station primarily operates a three-person engine that toggles with an ambulance. The station also has a climate-controlled outbuilding that is temporarily housing the IT department during the administration remodel in 2024.

**Condition** – The building, although small for a modern fire station, appears to be well maintained. The station does not meet current NFPA 1500 standards. Significant safety concerns are that it lacks a separate room for turnouts; the fitness area is located in the apparatus bay; lacks a central alarm; lacks a decontamination area and lacks an automatic sprinkler system. **See Exhibit C.**

**Recommendation** – Although not as a high priority as Station One, this station should be remodeled/replaced/rebuilt so that it meets current standards. The FCI model and an architect may be helpful in determining the right path. The lack of safety features may also affect the operational readiness of this station. The pending Station Five, located 2.8 miles away, provides a unique opportunity to temporarily relocate Station Two crews until Station Two can be corrected. Ironwood assesses this to be a medium priority, as the budget allows.

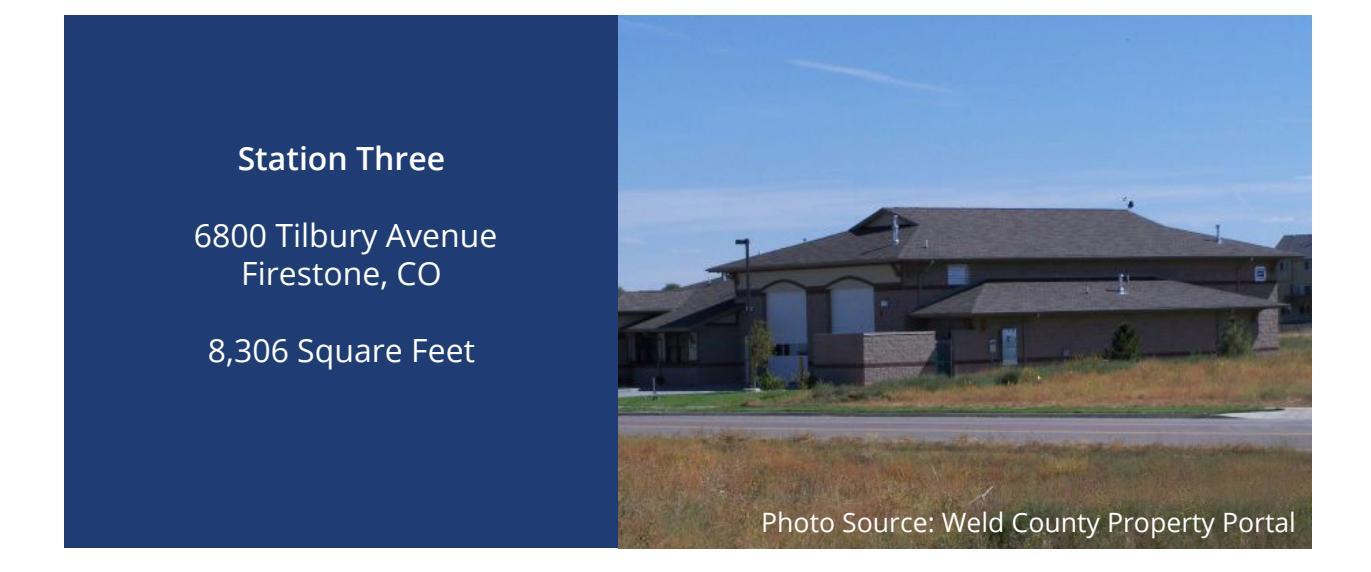
Station Three was built in 2007 and is 8,306 square feet. This station nicely blends with the surrounding residential neighborhood. The station houses six personnel and operates two front-line apparatus: an engine and an ambulance. The station also houses a water tender and a reserve ambulance.

**Condition** – The station appears to be well maintained and is adequate for a sixperson station. Although Station Three has spacious bunkrooms, it does not have separate bunkrooms to accommodate privacy.

**Recommendation** – FFFD should make a reasonably timed plan to update Station Three so that it meets current NFPA standards. With this remodel, the station should also address privacy issues related to mixed bunkrooms and the use of Jack and Jill bathrooms.

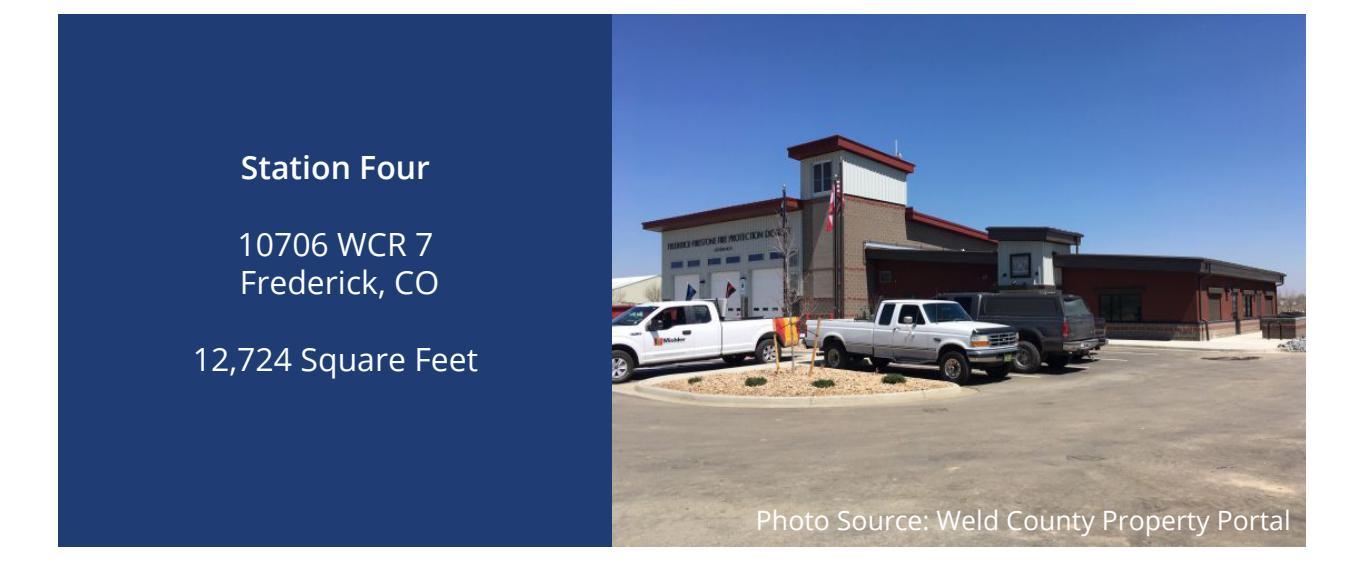
Station Four is the district's newest station, having opened in Spring 2019. The station houses four personnel that cross staff between a heavy rescue and a ladder tower. The station also houses a Type 6 brush engine and a trench rescue trailer. This station is primarily responsible for technical rescue and wildland responses. The station is unique in that it has many training props built into the structure such as a rope rescue tower.

**Condition** – Since this station was built in 2018, it is in very good condition and meets all NFPA 1500 standards. The crews reported that they like the durability and low maintenance of the polished concrete floors, a feature that should be in all future stations. It appears that some technical rescue gear is stored in the apparatus bay.

This station uses multi-occupancy bunkrooms and Jack and Jill bathrooms. As reported with Station Three, these designs may affect firefighter morale, operational readiness and cause sleep deprivation. Likewise, there is a problem of using totes on top of small lockers. The site visits also revealed some minor housekeeping issues in the bays and the blocking of safety-related ventilation systems. **See Exhibit E.**

**Recommendation** – FFFD should rectify the issue with the ventilation system and bay clutter. Although a low priority, FFFD should evaluate its ability to remodel this station's bunkroom and bathroom configuration and correct the drainage issue in the front apparatus bays.
